The Locomotive

THE HARTFORD STEAM BOILER INSPECTION AND INSURANCE CO.

INDEX TO VOL. 42—1938-1939

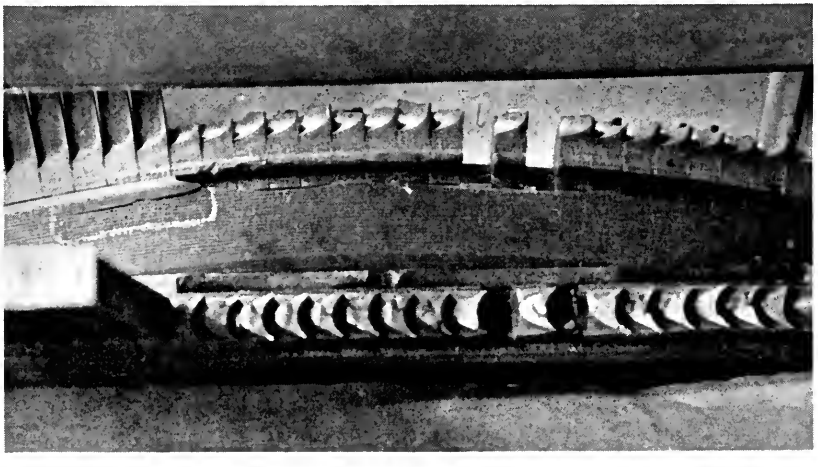
Figure 2—Taken with the aid of a mirror, this picture gives a close-up view of both the top and one side of the broken section in the turbine rotor shown in Figure 1.

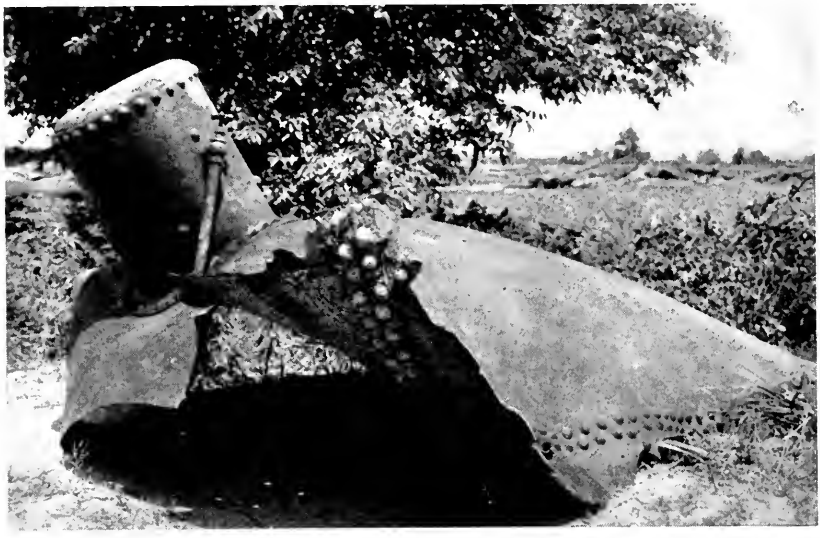
Figure 1—A crack in a longitudinal lap-seam caused the explosion of this boiler. Three men were killed and twelve others injured, eight of them seriously.

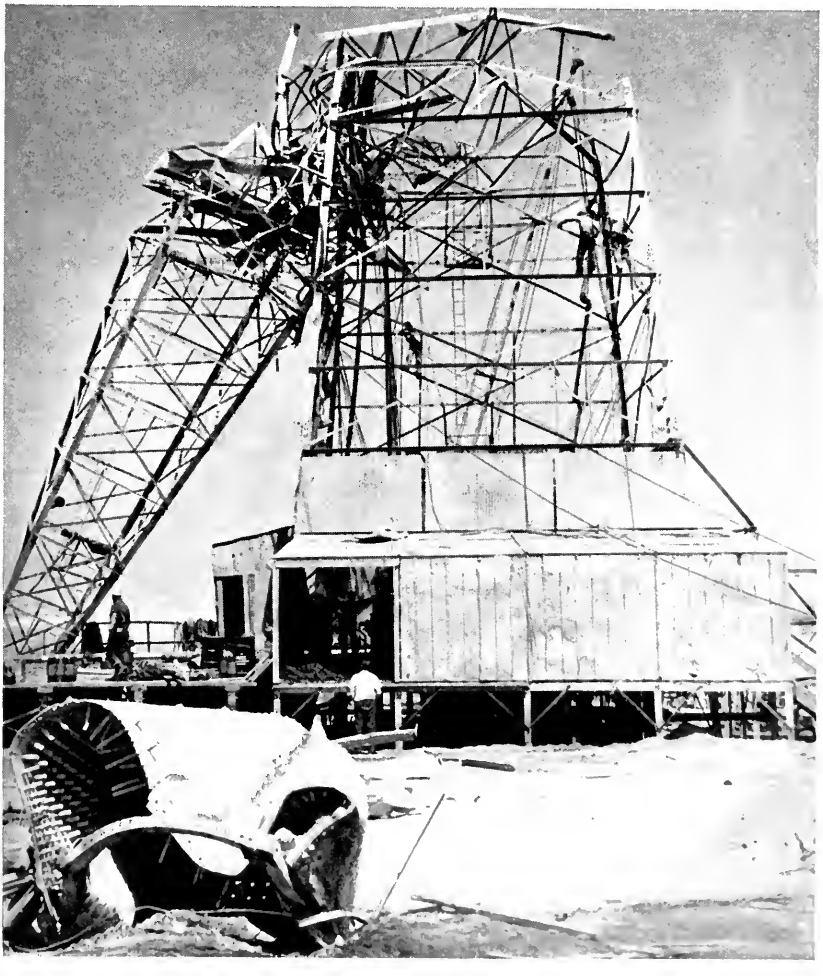
Figure 2—Derrick in an oil field wrecked by an explosion of an oil-well drilling boiler which was located a quarter of a mile away. The boiler's fire box that crashed into the derrick is shown in the foreground.

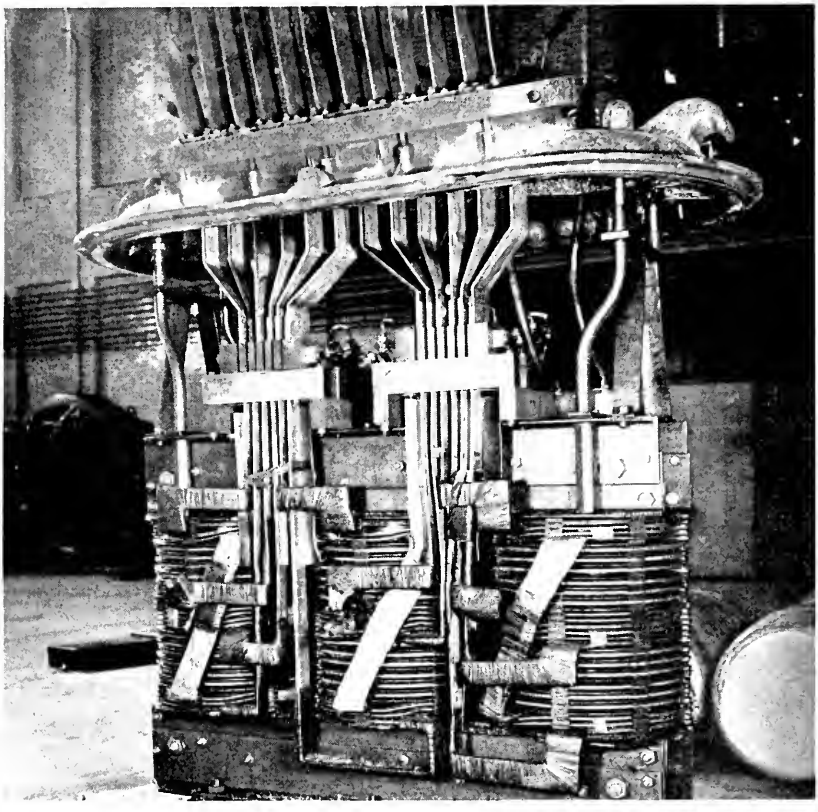
View of a three-phase, 800 kv-a transformer, removed from its casing for an examination after it had failed to operate. The source of trouble was readily determined, for as shown in the photograph the short-circuited coils in the center phase were plainly visible. Further investigation revealed that several high-tension windings had burned through completely and a number of secondary coils had been damaged as well. Intermittent excessive overloads which produced both severe mechanical stresses between the windings and excessive heating were believed to have been the cause. The cost of repairs to the transformer was about $1,000 although production loss and extra expense incurred for a temporary transformer while repairs were being made exceeded $12,000.

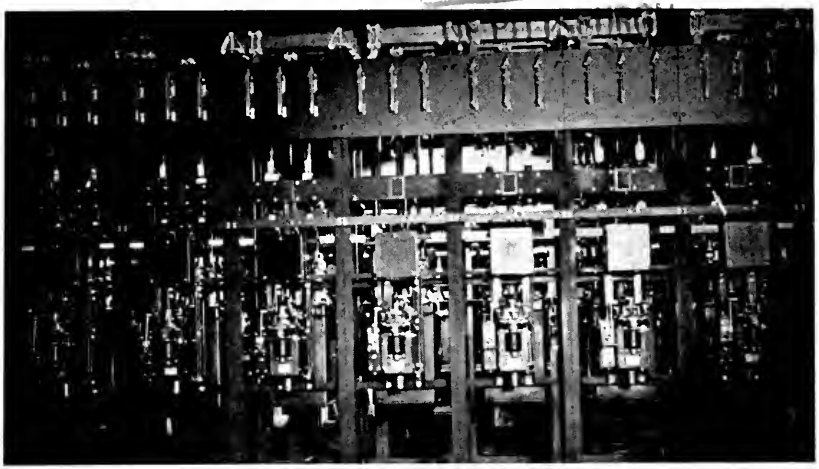
Production Stops When Switchboards Fail

BELOW are a few actual losses indicating some of the many accidents that can happen to switchboards. In all these cases, production was curtailed for a number of hours or for several days. Through failure of only a small part, buses may be short-circuited and a plant's entire output stopped.

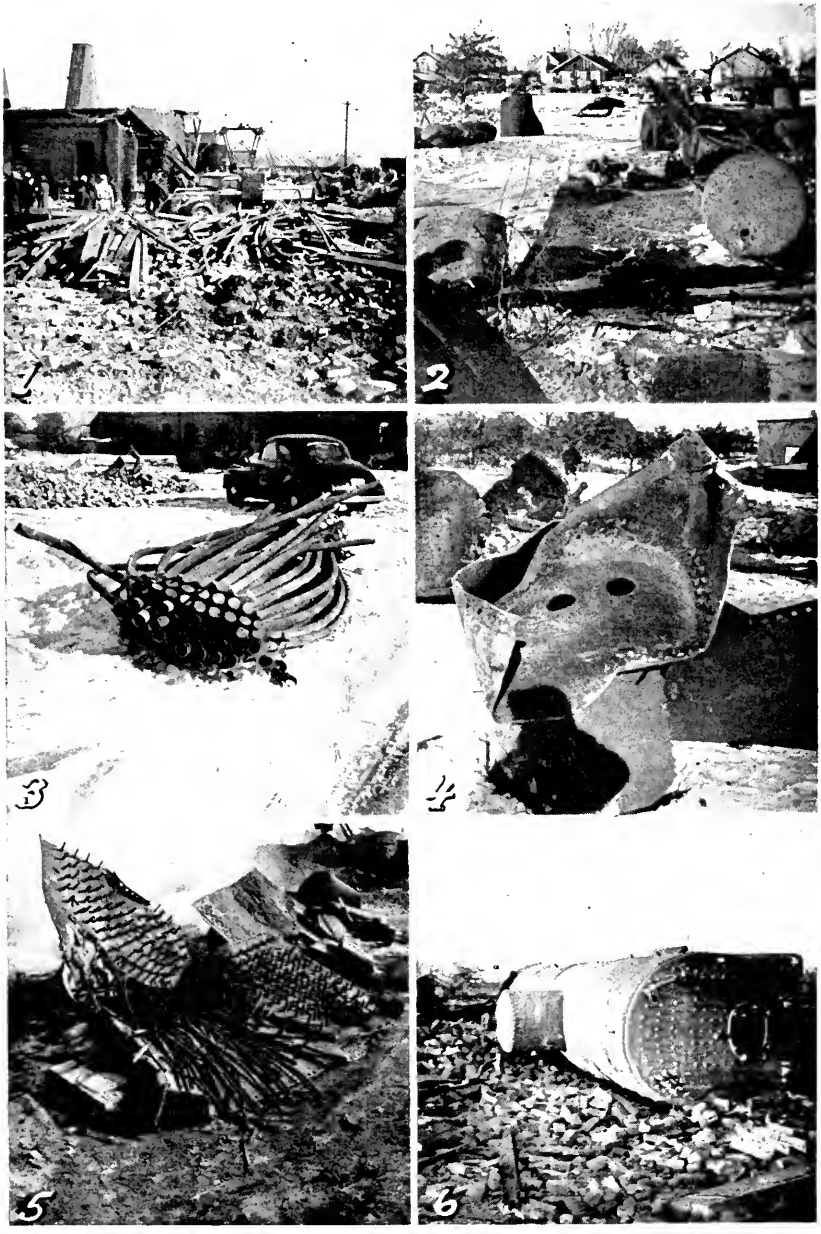
A Boiler Explosion Caused this Wreckage

LAST February an explosion of a stationary locomotive-type boiler at a roundhouse in Minnesota killed three railroad employes and injured a fourth seriously. All four men were in a boiler house adjacent to one end of the roundhouse building when the accident occurred. An eight-stall section of the roundhouse and the boiler house, both of brick and wooden frame construction, were demolished. The pictures on the opposite page, taken at the scene of the disaster, indicate graphically some of the havoc which resulted from this explosion.

The photograph in Figure 1, giving a general view of the wreckage, was made as a search of the debris for the missing workmen was being started. Of the several parts of the disrupted boiler and stack shown in Figure 2, the flat sheet in the center is the manhole course in which the initial point of failure is believed to have occurred. The tubes, steam dome and the wrapper sheet are shown in Figures 3, 4 and 5, respectively. All these and other parts of the boiler were scattered over a wide area. Figure 6 shows another boiler of the same size and type, which was also in operation, where it was thrown by the concussion, 60′ from its setting. Several automobiles in the roundhouse were damaged, a wooden coal bin was wrecked, and various other pieces of equipment such as a feed-water heater, an air receiver, two feed pumps, piping and wiring were destroyed. In addition, stained glass windows were broken in two churches, as also were a number of windows in residences, all several blocks away.

Although a complete investigation was made in an attempt to determine the exact sequence of events which brought about the explosion, the definite cause remains largely a mystery. The boiler had been shut down a few days previously for cleaning, inspection and repairs, and apparently it had not been fired again until about two and one-half hours before it blew up. Information could not be obtained from the operators who may have known what happened, as unfortunately they were killed, but from an examination of the shattered parts of the boiler, the conclusion was reached that over pressure was the probable cause.

Approved pressure for the boiler was 110 lb and the safety valve was stated to have been set at about 100 lb. However, when the safety valve was tested after the accident, it did not open until a pressure of 250 lb had been reached. Moreover, the main-steam stop-valve for the boiler was reported as having been closed, indicating that there had been no outlet for the steam as it was generated. In this type of boiler a common cause of explosions is overheating and failure of the crown

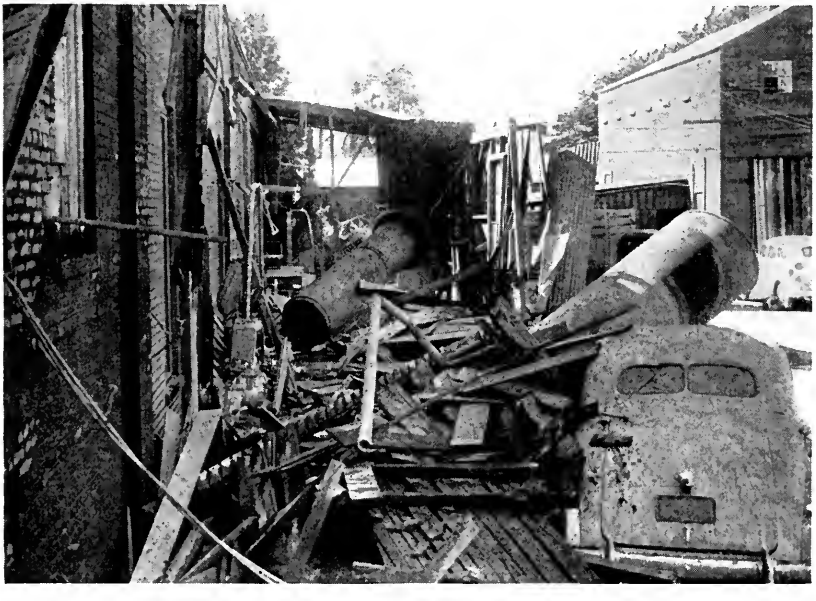
Damage at a creamery and cold storage plant caused by a boiler explosion as a result of low water which, in turn, was attributed to failure of automatic controls. The furnace in the boiler overheated, collapsed and ruptured. Property loss was nearly $5,900.

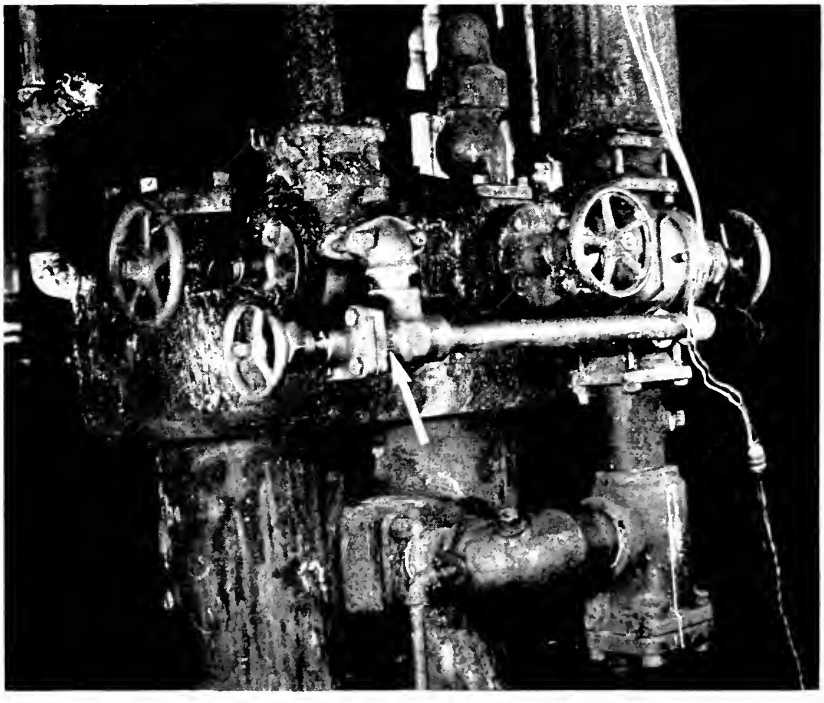
Figure 1—Four people were injured and a $37,000 property damage loss was caused by the breaking of a by-pass valve on this ammonia compressor. Arrow indicates the point where the break occurred although a new valve had been installed when this picture was taken.

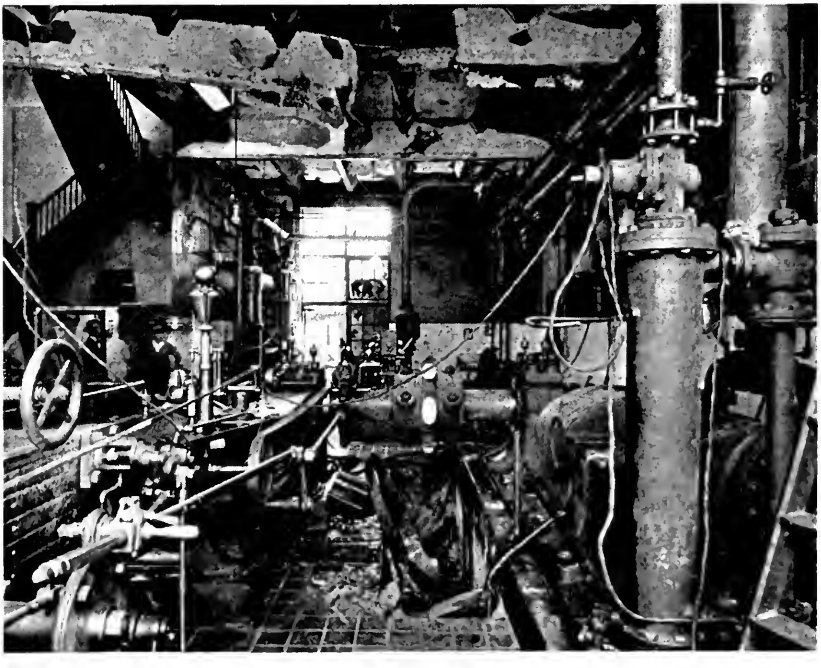
Figure 3—When a 12′ flywheel on this steam-driven ammonia compressor ran away, the resultant property damage amounted to more than $10,000.

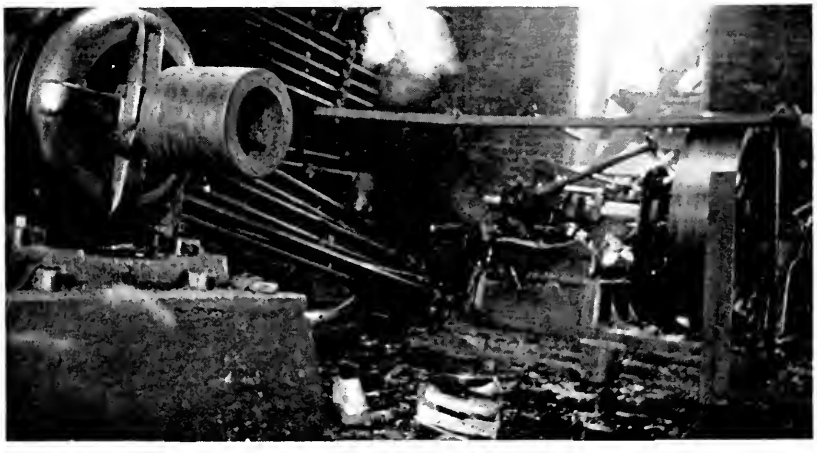
The following account of an explosion shows the danger in running a motor-driven compressor with the stop valve closed in the discharge line and also shows the value of an overpressure-actuated cut-out for the driving motor. According to the statement of the operator who barely escaped being killed, the explosion was accompanied by a blinding flash of fire. It was found that he had started the compressor with the discharge-line stop valve closed and had operated the machine in that manner for nearly four hours. As a result, the ammonia gas temperature increased greatly and the compressor overheated. What actually happened then isn't known but the conjecture is that a piston seized and caused a shock which broke the crankcase. The hot oil vapor or

Figure 4—Only the bottom of the crankcase, the shaft and the wheel remained after this vertical twin-cylinder belt-driven ammonia compressor exploded. The cause was attributed to a combustion explosion in the crankcase. $7,500 was the estimated damage.

ammonia gas thus released mixed with the air and was ignited almost instantly as evidenced by the sudden flash of fire.

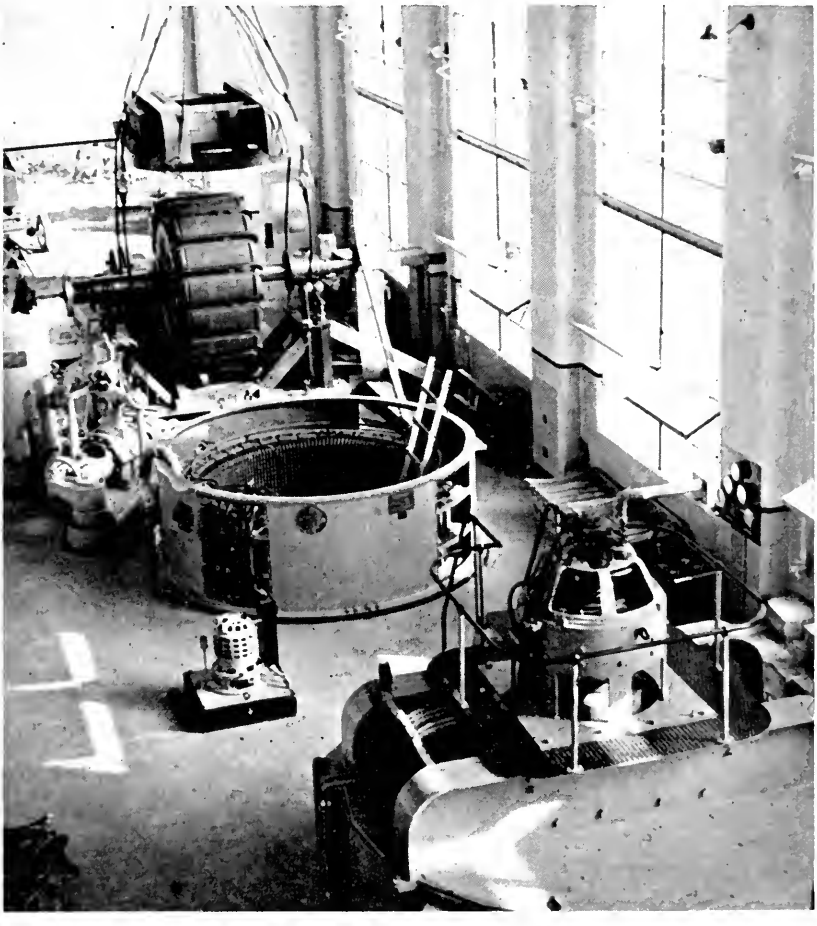
Scene in a California power plant showing the generator ends of two vertical water turbine-generator units, each of 7,500 kw capacity. One generator has been dismantled for complete rewinding of its stator, necessitated by failure during a severe electrical storm. The total loss, direct and indirect, was $37,000.

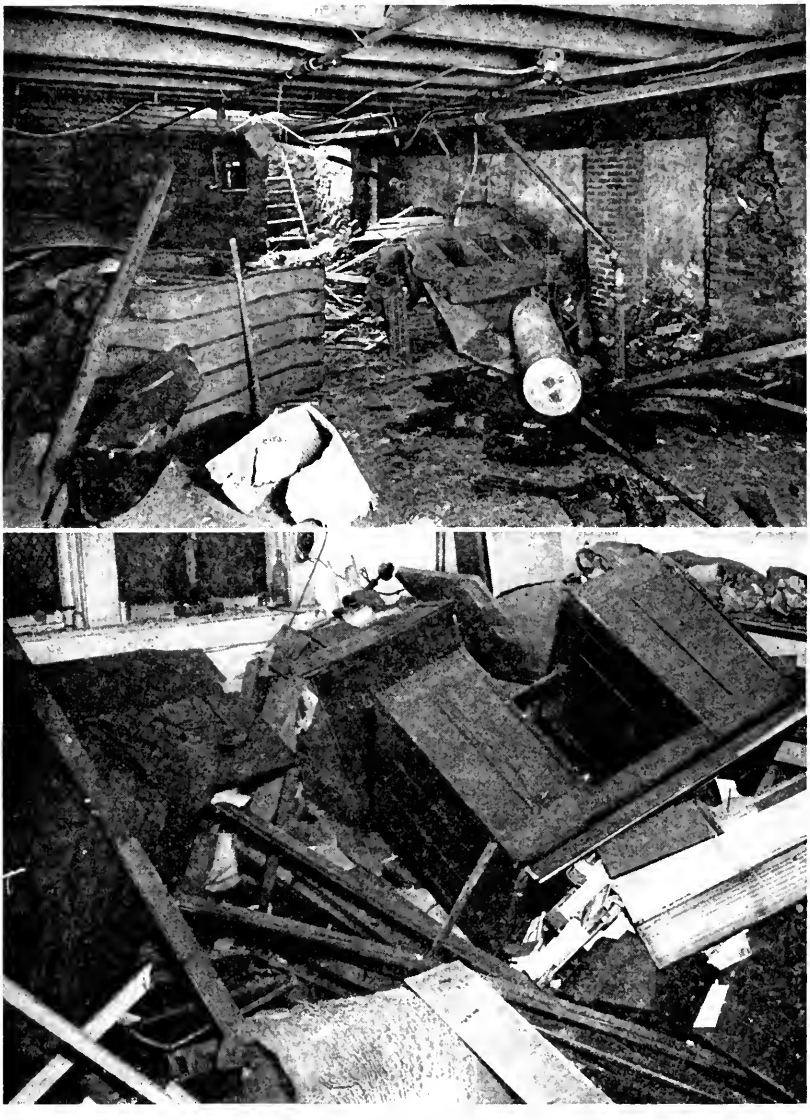
Figure 1 (Top)—An explosion of a cast iron sectional heating boiler caused this damage. A new boiler, it had been placed in service for the first time only a short while previously.

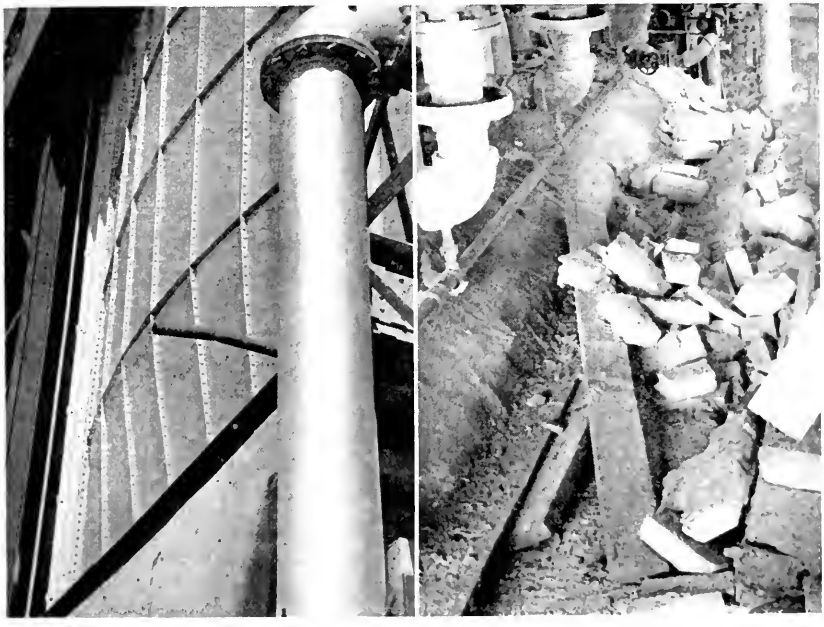
Figure 5—(Left) and 5A (Right)—Two pictures showing some of the damage caused by a furnace explosion to a large water-tube boiler in an Arizona utility power house. The one at the left shows one wall of the boiler's economizer bulged out several inches, while the other gives a view of damaged brickwork in the top of the setting.

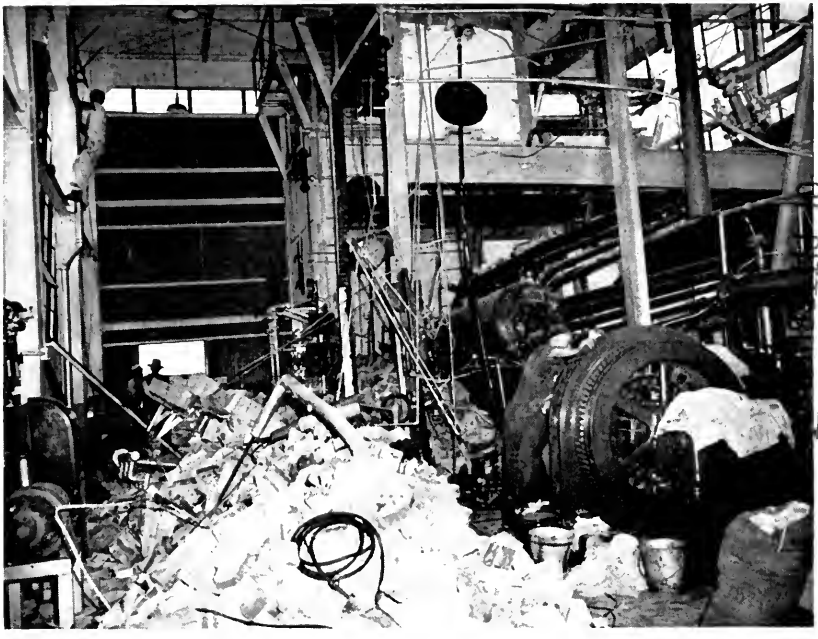
What Happens To Production?

ALTHOUGH many accidents in power plants may not be as damaging as the one that caused the wreckage shown above, they can happen wherever power equipment is operated. Often, the resultant indirect loss from curtailment of output is far greater than the direct loss from property damage.
